**CLOSED CIRCUIT TELEVISED INSPECTION PROGRAM  
FOR THE  
JONES FALLS SEWERSHED**

**CITY OF BALTIMORE PROJECT NO. 994**

**CCTV REVIEW MANUAL**

**JONES FALLS COLLECTION SYSTEM  
EVALUATION AND SEWERSHED PLAN  
CITY OF BALTIMORE PROJECT 994**

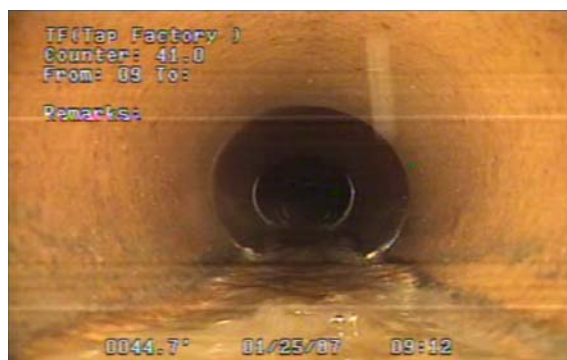
Acceptable Flow Level (Flow Below Camera)

**Excessive Flow:** Excessive flow level in a pipe is described as flow levels that obstruct the inspection camera from providing a clear and unobstructed view/image of the interior of the pipe for evaluation. For the purpose of this project, an inspection will be considered acceptable if the inspection camera proceeds in excessive flow (sag in a pipe) for short distances assuming the pipe before and after the sag is in serviceable condition. Inspections will not be accepted when a CCTV camera operator attempts to turn the inspection camera to the side or attempts to ride-up the side of the pipe to keep the camera above the flow line. If the pipe dips underwater at any point during the survey an "MCU" code should be noted and if the camera is underwater for more than 10% of the total length of the pipe being surveyed, the survey should be failed and marked as "Excessive Flow". The following criteria is outlined in the PACP manual and shall be used for determining acceptable and unacceptable flow conditions in a pipe segment during the inspection process:

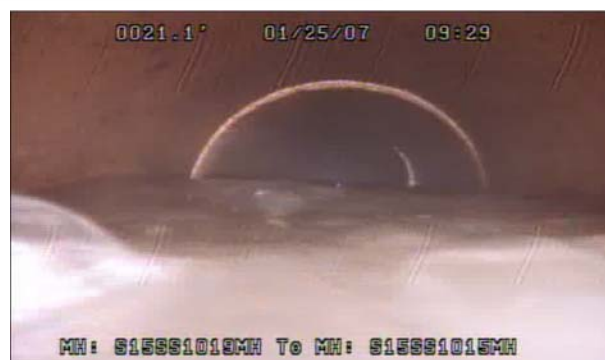
Unacceptable Flow Level (Can't See Entire Pipe)

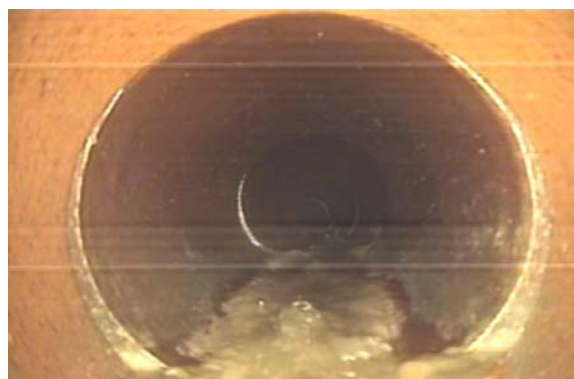
Acceptable Lighting For Inspection

**Poor Lighting:** Lighting during the inspection should be adequate to fully illuminate the entire pipe section in view of the CCTV camera, but not over illuminate the image where as to create distortion of the image. Low lighting will likely occur in larger diameter pipes or when dark pipe materials such as HDPE, DIP, etc. was used in the construction of the system. In order for an inspection to be considered acceptable, the complete interior of the pipe must be visible to detect and code all defects, etc.

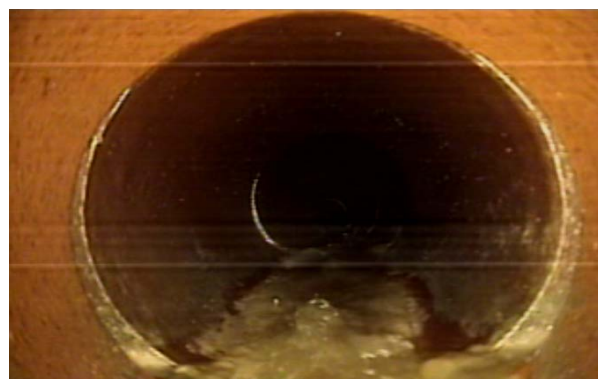
Unacceptable Lighting For Inspection

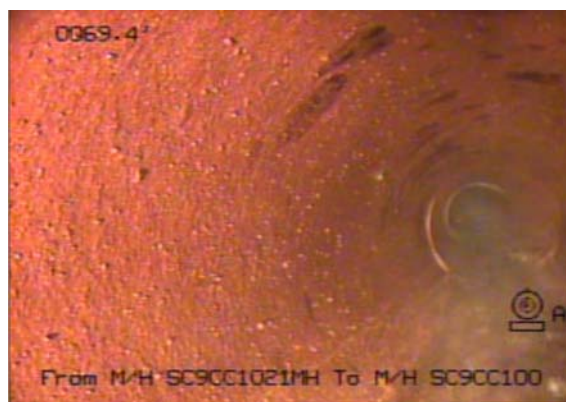
Camera/Image Not Centered

**Camera Not Centered:** In order to provide a complete and unobstructed view of the pipe for inspection, the camera must be appropriately sized and centrally positioned to adequately view the complete interior of the pipe being inspected. This means the camera should be centered both vertically and horizontally in the pipe being inspected and the complete interior of the pipe must be visible for inspection.

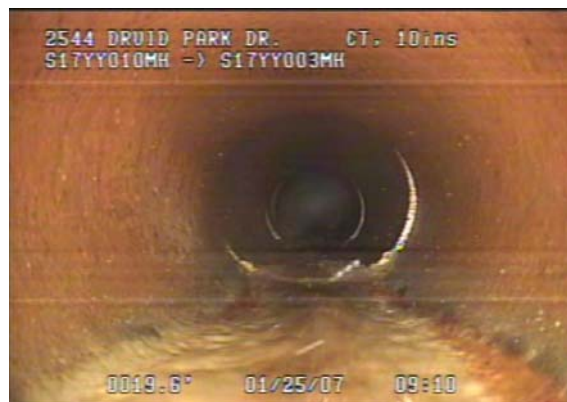
Camera/Image Adequately Centered

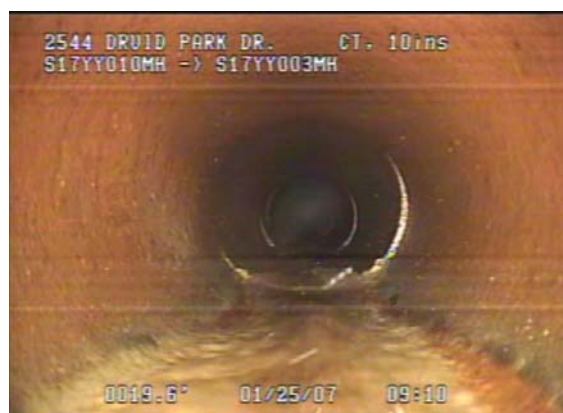
Clear/Acceptable Image Quality

**Image Quality/Distortion:** In order to provide a complete and thorough inspection of the pipe, the inspection camera must provide an image that is clear and not distorted by flow levels, water, steam or debris on the camera's lens. The camera must be centered in the pipe so as not to exaggerate the image (i.e. amount of offset in joints, pipe ovality, etc). The image must be clear and allow for a thorough visual inspection and interpretation of the interior of the pipe.

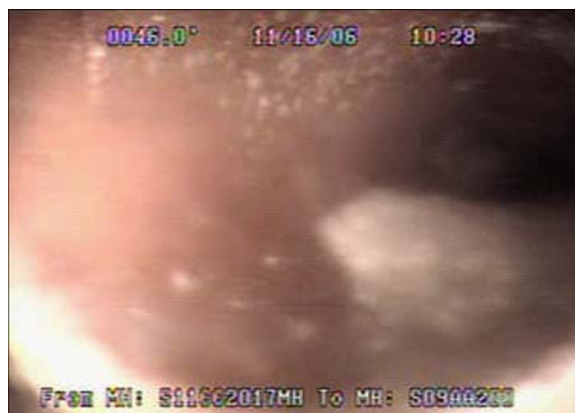
Distorted/Unacceptable Image Quality

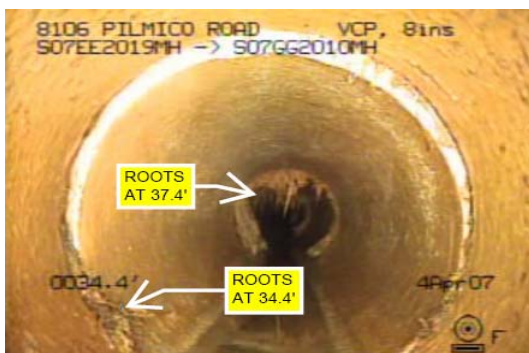
Significant Defect (Roots) In Pipe Not Noted

0.0	ST					
0.0	AMH					
0.0	MWL		5			
3.1	MWLS		10			
10.8	RFJ				03	
13.1	RFJ				08	04
16.6	S01 RFJ				03	
20.6	H				03	
55.6	TFA	6.0			03	
73.7	TFA	6.0			03	
92.0	JOM

Significant Defect (Roots) Not Noted

Significant Defect Not Noted: A Significant Defect Not Noted (PACP Structural, O&M, Construction & Miscellaneous Features) should be defined as a defect that has not been recorded as part of the inspection but impacts the structural condition of the pipe or requires system maintenance. These include structural defects such as cracks, holes, offset joints, roots, etc. and maintenance related items such as grease and debris. These defects should always be coded per the PAC Program requirements. Note: some of the PAC Program codes contain threshold limit values such as joint offsets and defects. Other defects may require judgments by the observer/reviewer whether to code or not. Defects that appear to be only cosmetic in nature and DO NOT impact the structural integrity or the operation of the sewer do not require coding. As a general rule, if more than 3 significant defects are not coded, then the inspection should be rejected.

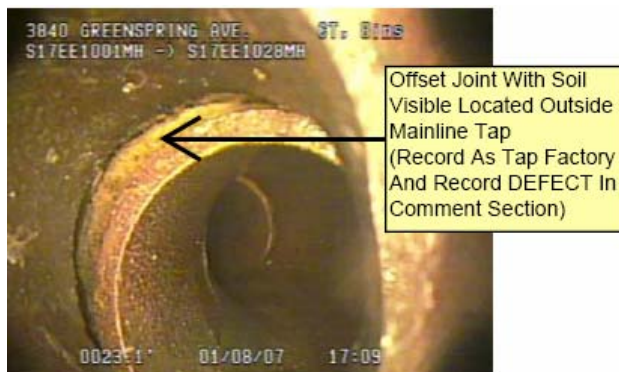
Example of Defect Located Outside Tap - Factory Made (Code as TF - Then Indicate In Comment "DEFECT")

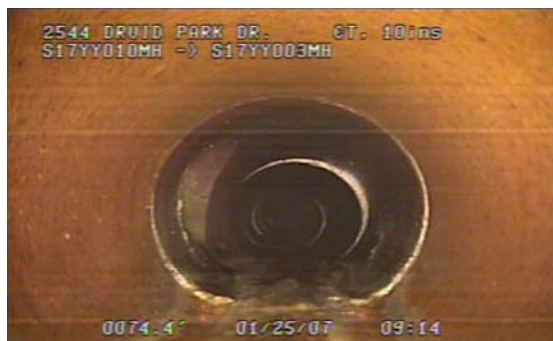
Acceptable Image - Centered In Pipe

**Excessive Camera Movement:** The CCTV camera should always be centered in the middle of the pipe and the camera head not excessively panned or zoomed during the inspection. The camera should be stopped and centralized on defects while the operator views and records the defects. The operators objective in positioning the camera should be to provide a perspective similar to that found in the PAC Program reference manual.

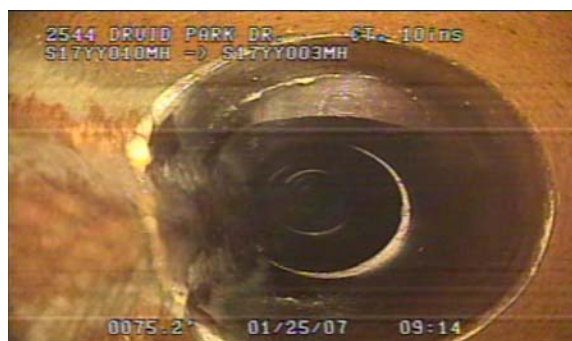
Unacceptable Image - Image Rotated To Side

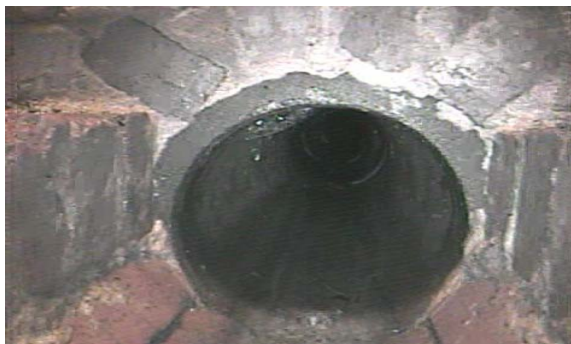
Acceptable Color Inspection

**Image Color:** The CCTV camera should record all inspection images in color allowing the observer to review details of the inspection. Color images allow the observer to determine items such as pipe material, lining installation, severity of defects, etc. which otherwise could not be detected with a black and white image. Any inspections completed in black and white will not be accepted.

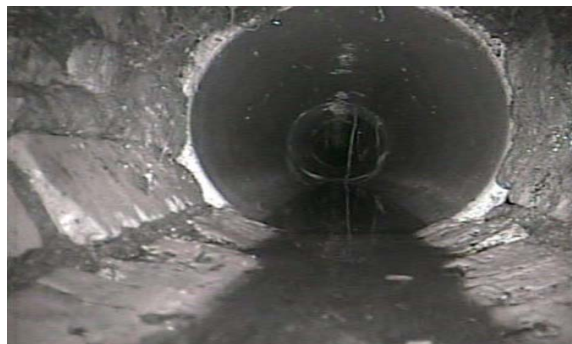
Unacceptable Black & White inspection

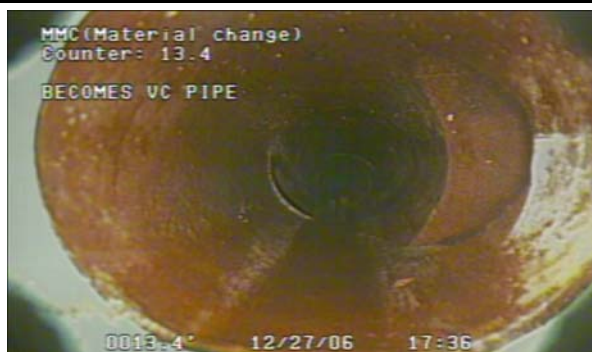
Acceptable Overlay (Entries Can Be Seen)

**Overlay Defects:** All video overlay images shall be clearly visible to the reviewer and include all PAC Program defined items. Overlay color that is not clearly visible over the image will not be acceptable. The camera length image shall always be visible by the reviewer so defect locations can accurately be noted.

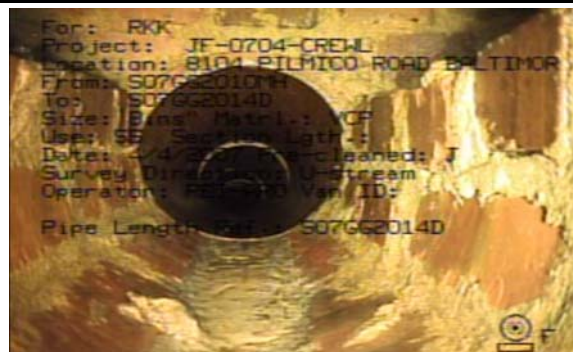
Unacceptable Overlay (Entries Can't Be Seen)

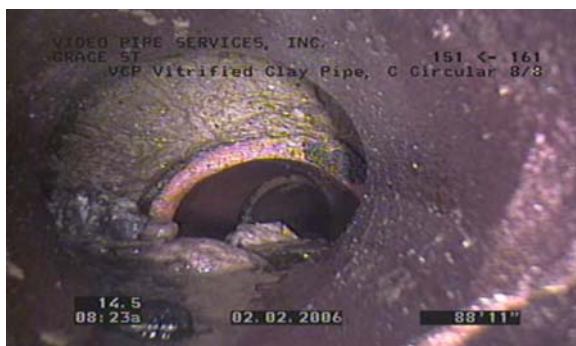
Lateral Cleaning/Debris Removal

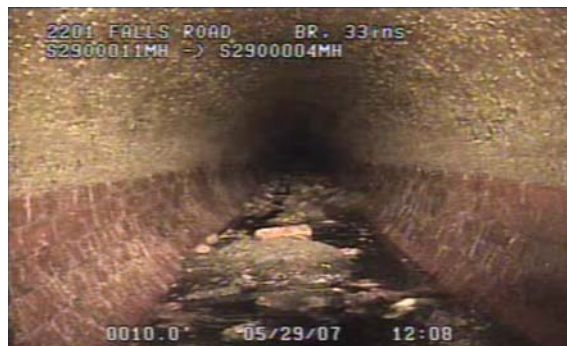
Mainline Cleaning/Debris Removal

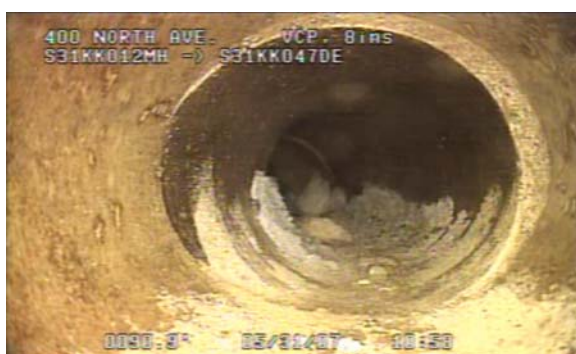
Lateral Grease Removal

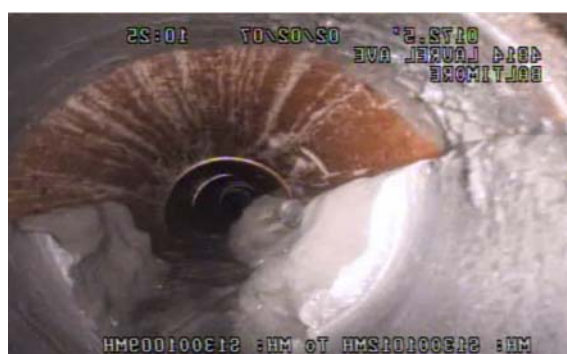
Mainline Grease Removal

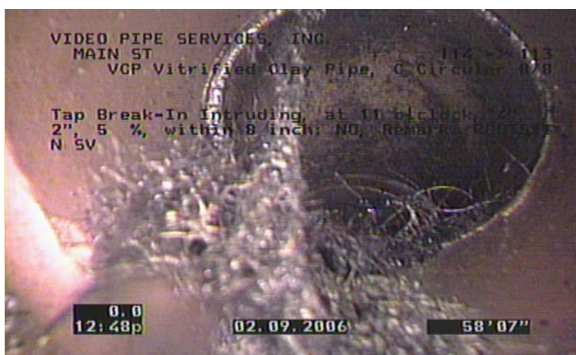
Lateral Root Removal

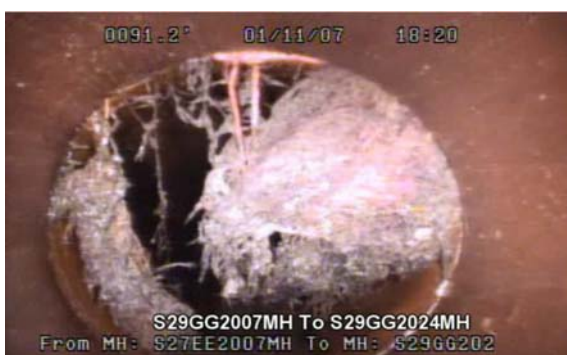
Mainline Root Removal

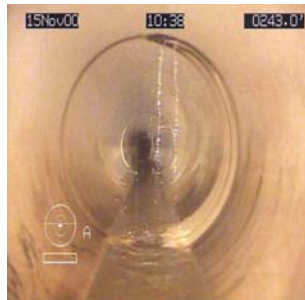
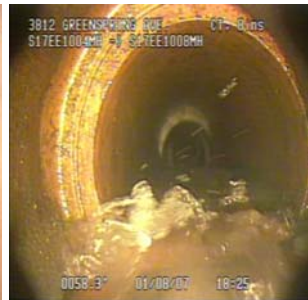
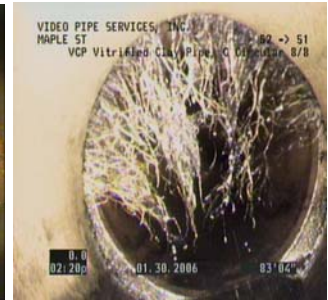
### LINE ENTIRE SEWER SEGMENT (MH TO MH)

Typically, the entire sewer segment will be recommended for lining if the following criteria is met:

- If Multiple Cracks (Circumferential, Longitudinal, Multiple) Are Present In At Least 30% Of The Pipe Segment
- If Active or Signs Of Infiltration Are Present In At Least 30% Of The Sewer Segment
- If Offset Joints Are Present In At Least 30% Of The Sewer Segment
- If Roots Are Present At More Than 20% Of The Joints

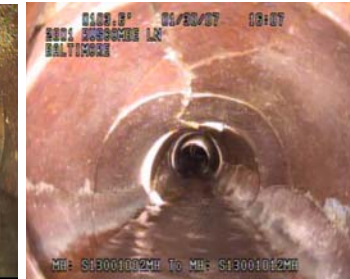
### POINT REPAIR (DIG-UP)

Typically, point repairs (dig-up to repair) should be recommended when a pipe is collapsed or the pipe cannot be repaired in-place. The following should be used as general criteria for the point repair:

- Pipe is collapsed or an object is in the pipe
- Holes are present in the pipe and soil has entered the pipe
- Pieces of pipe are missing and soil has entered the pipe
- The ovality of the pipe exceeds 15%

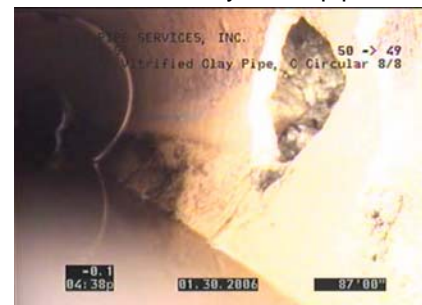
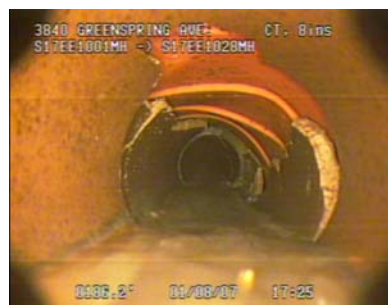
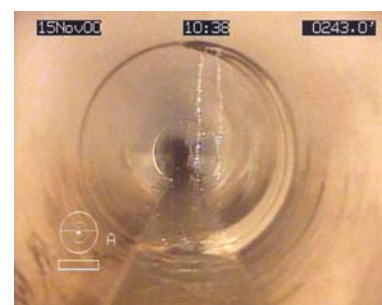
### INSITU SPOT REPAIR

Typically, Insitu type spot repairs should be recommended if the following criteria is met:

- Holes are present in the pipe where soil is visible but has not entered the pipe
- Pieces of pipe are missing and soil surrounding the pipe is visible but has not entered the pipe
- Severe cracking of the pipe is present in an isolated section not greater than 6-feet in length
- The ovality of the pipe does not exceed 10-15%

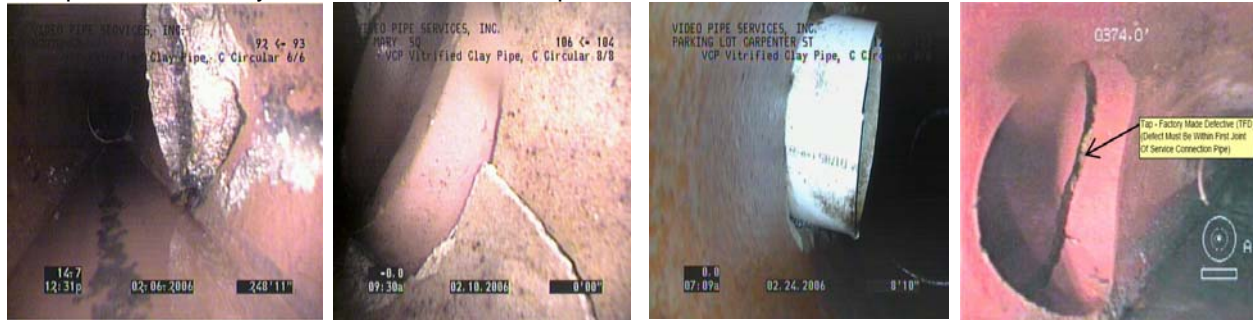
## LATERAL CONNECTION REPAIR

Typically, lateral connection repairs are recommended where defects are located directly at the lateral/service connection to the mainline sewer pipe. This is considered to be to the joint of the service connection. It is common to have as much as 30% of your total system I/I enter the collection system at this location. Therefore it is important to identify these deficiencies for repair.

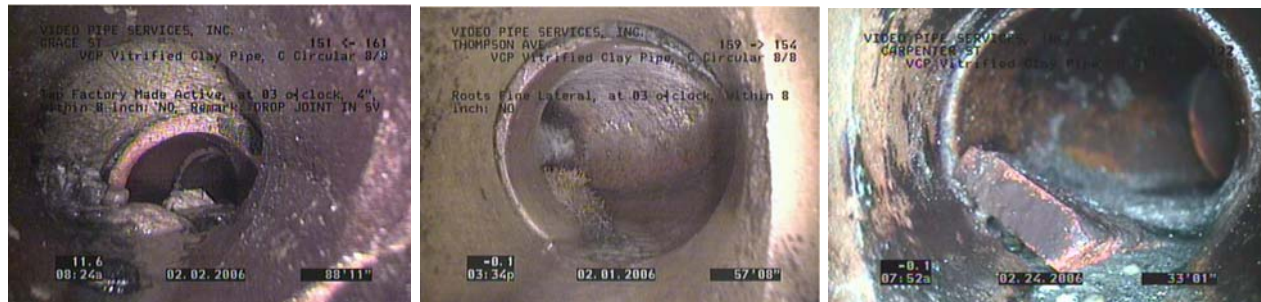
## LATERAL REPAIR (LATERAL DAMAGE ONLY)

Typically, repairs to the lateral connection piping should be recommended if the piping (located after the initial connection joint to the mainline sewer) shows signs of deterioration or I/I. Again, service connection deficiencies typically represent as much as 30% of a systems total I/I. The following criteria shall be met to recommend lateral repairs:

- Offset joints in the service connection piping at or past the connection point to the mainline sewer
- Roots are present in the lateral
- Active or signs of infiltration are present in the lateral

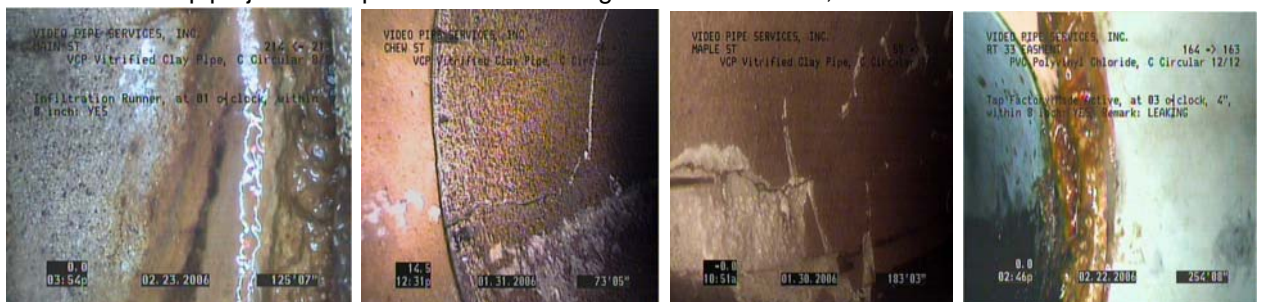
## GROUT PIPE JOINTS

Typically, joints or other infiltration points identified during the CCTV inspections should be recommended for pressure grouting if the following criteria is met:

- Active infiltration is identified in cracks or pipe joints
- Signs of infiltration such as wall staining, calcification, cracks, etc. are identified
- Offset pipe joints are present that show signs of deterioration, cracks or infiltration

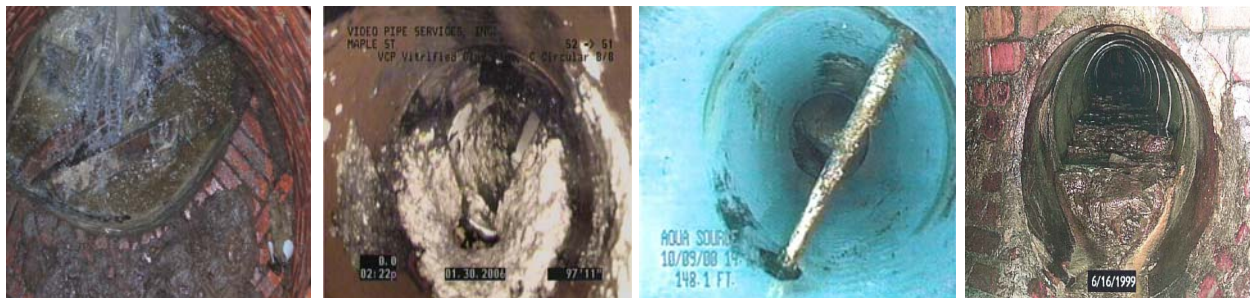
The presence of medium to large sized obstacles or obstructions that are likely to cause a serious obstruction to the flow of the sewer and reduction in hydraulic capacity should be recommended for removal.

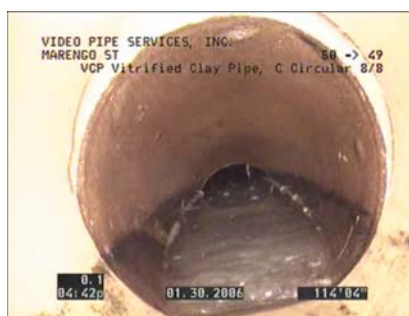
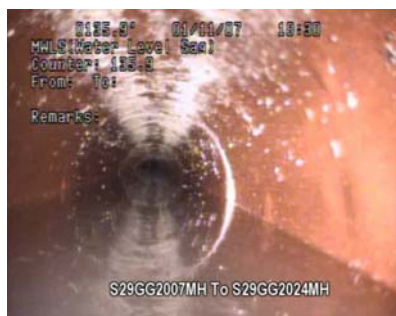
Sags or low sections in a sewer should be identified as part of all CCTV inspections. A sag is defined as a condition where the grade of the sewer pipe is not continuous and results in water being trapped by the reverse grade change. Typically large sags or low points in a sewer segment which constitute a 30% cross sectional increase in the continuous flow level of the pipe should be recommended for correction to improve the hydraulic characteristics of the sewer.

0.0		ST					
0.0		AMH					
0.0		MWL		4			
32.5	S01	RFJ			J	08	
87.7		TFA	6.0				09
87.7		RFL					
91.8	F01	RFJ			J	08	
91.8		RMJ		25	J	03	
99.2	S02	RFJ			J	12	02
135.9		MWLS		45			
145.3		MCU					
153.8	F02	RFJ			J	12	02
153.8		MSA					
154.1	S03	RFJ			J	03	
154.1	S04	RFJ			J	09	
168.9	F03	RFJ			J	03	
169.6	F04	RFJ			J	09	
170.0		AMH					
170.0		FH

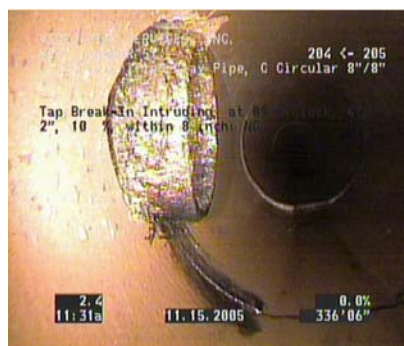
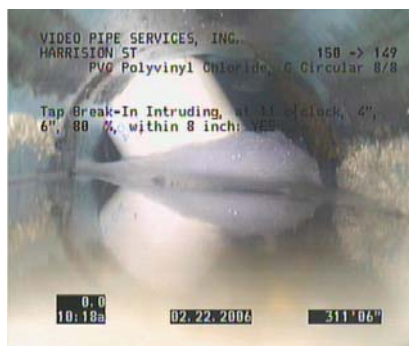
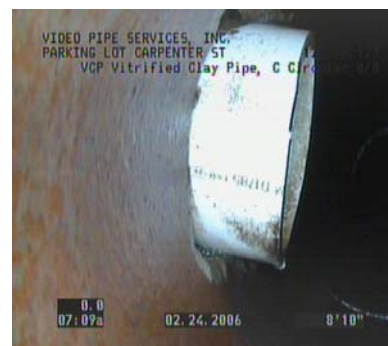
Intruding service connections or sometimes called "Hammer Taps" are caused when a retrofit service connection is installed into the mainline sewer. These typically extend into the mainline sewer 2-inches or more. These need to be identified and removed if they extend to such a degree that they impede flows, prevent the inspection camera from passing the lateral, or if a lateral repair or CIPP liner is recommended for the sewer segment.
